## **MEMORANDUM**

**DATE:** September 11, 2015

**SUBJECT:** I-010-06 Idahoan Foods – Idaho Falls Facility, Staff Analysis supporting reuse permit issuance.

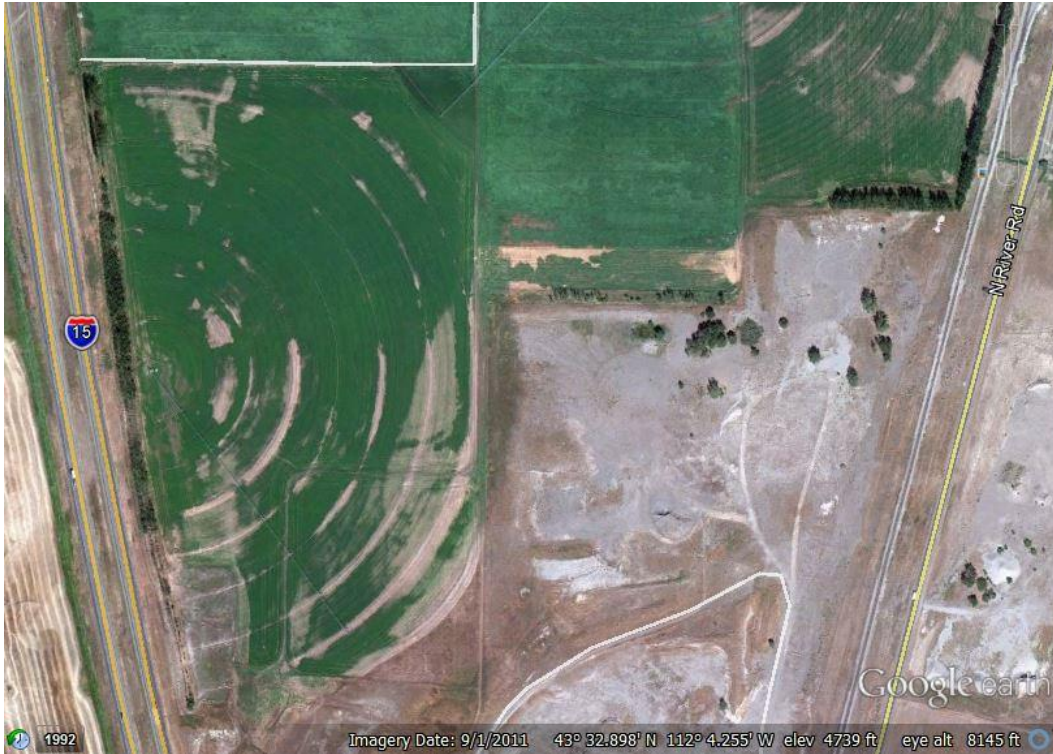
**Figure 9.** August 2011. The dry circles are closed, part-circle, or re-directed sprinklers at the wheel towers to try and keep the wheel tracks dry. But notice the dry areas between the towers, which can indicate that sprinkler sizes may have been designed too small, or the correct nozzles were replaced with nozzles that are too small.

One area of concern is that growing season hydraulic loading rates have been less than the crop irrigation needs (IWR) during the summer, as described previously in Section 4.6.2. It would be expected that crop yields and nutrient uptake rates would improve if growing season irrigation schedules were improved to more closely match the irrigation demands of the crops. Evidence of under-irrigation can be seen in the time lapse satellite photos available on Google Earth and shown in Figures 7-12. Pivot #1 (field #1) especially exhibits dry conditions in the year-after-year images. Field #1 images show both an under-irrigation scenario as well as potentially plugged sprinkler nozzles.

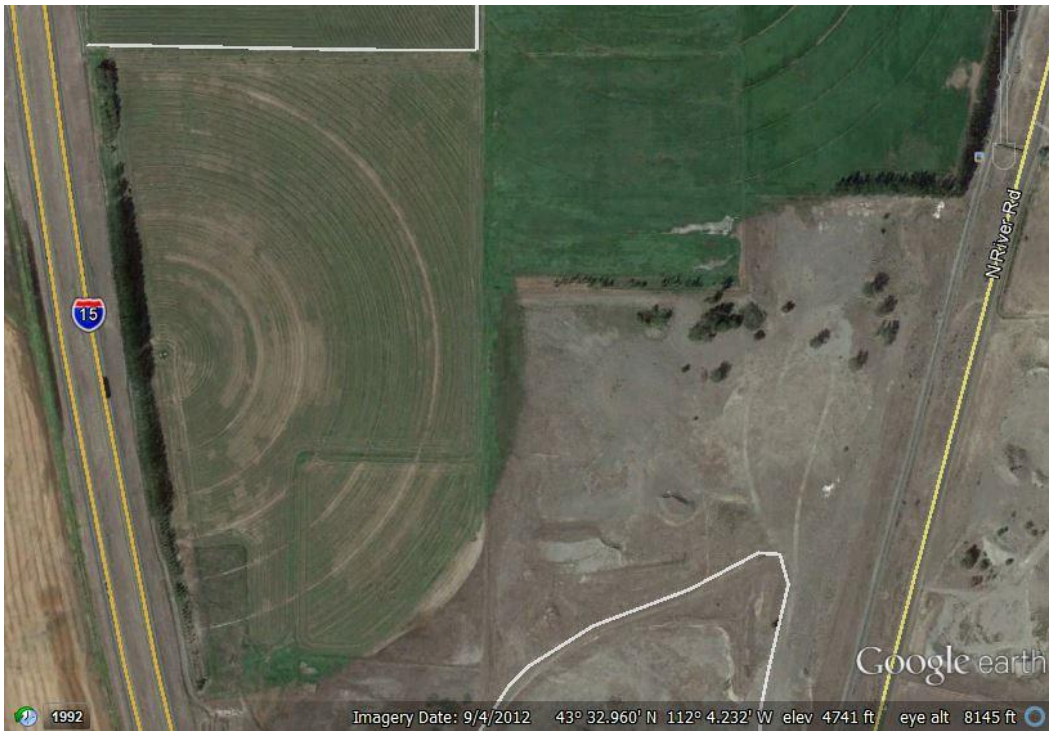
**Figure 10.** September 2012. There are large dry areas between the first and second tower, and between the second and third tower. Idahoan Foods should perform maintenance and check all sprinkler heads and nozzles to ensure that they are still the correct size as shown on the 'sprinkler chart' that was provided with the pivot at installation.

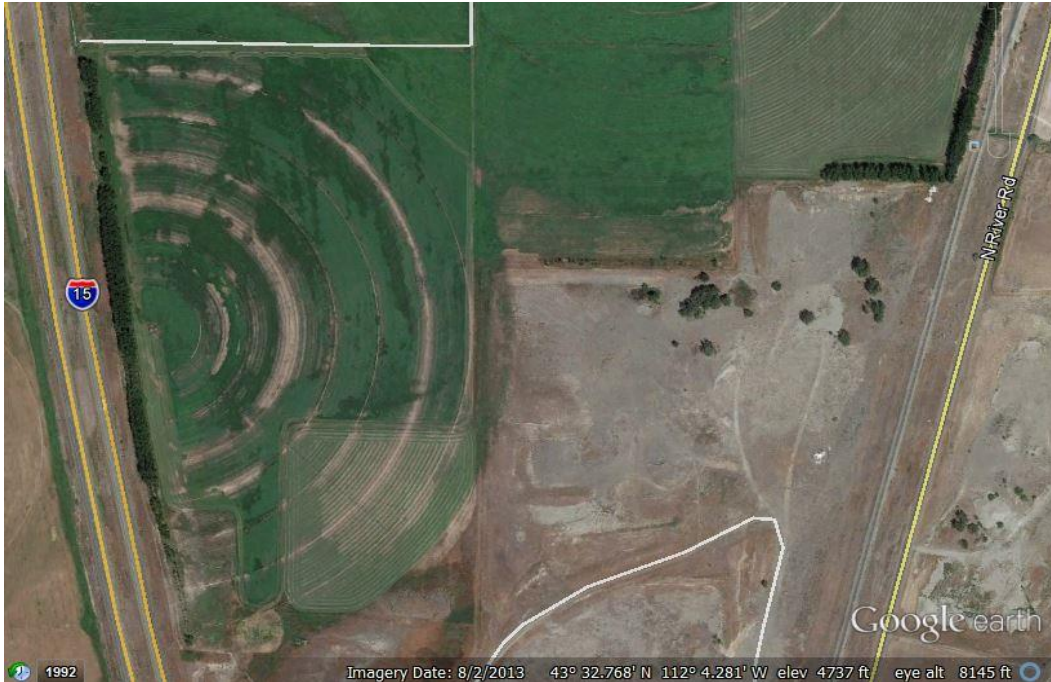
**Figure 11.** August 2013. The brown dry circle between the first and second tower indicates a plugged sprinkler nozzle. The dark green ring next to it indicates an oversized or missing nozzle (or a leak) that is over-applying. The large brown circles at tower #3 and #6 also indicates multiple sprinkler nozzles that are plugged or under-sized.

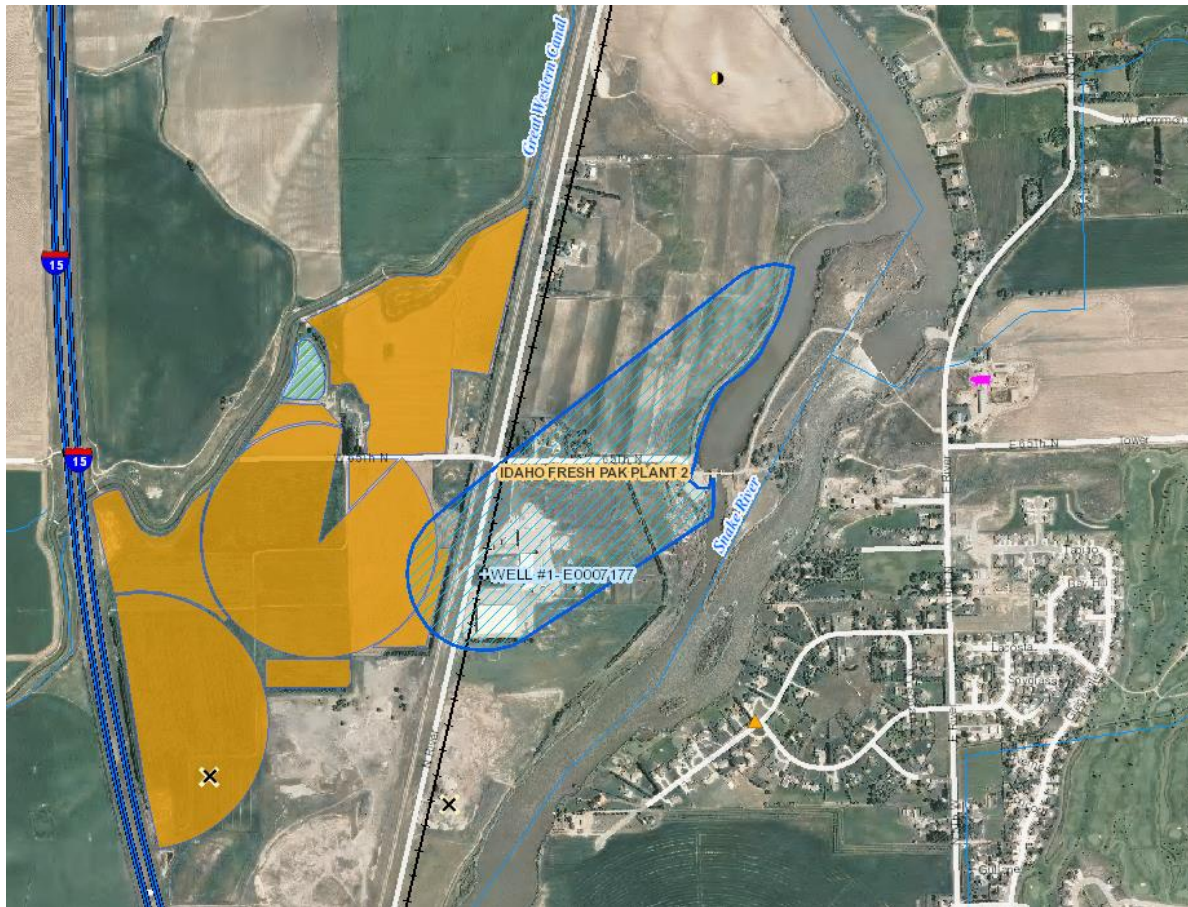
**Idahoan Foods Main Public Water Supply Well and Estimated Capture Zone** (Source: Source Water Assessment Summary Report: Idahoan Foods Idaho Falls Plant, PWS # ID7100083. DEQ, 2001)

Idahoan Foods' public water supply wells are located at the processing facility which is east and hydraulically upgradient of the reuse site. The main well is in the front yard of Idahoan's processing facility, approximately 500 feet upgradient of reuse field #2 (MU-02). The backup well is inside the facility and approximately 600 feet upgradient. Source Water Assessment maps showing the estimated capture zones for the two wells are included in Appendix A at the end of this analysis, and show that the locations of the two supply wells are acceptable.

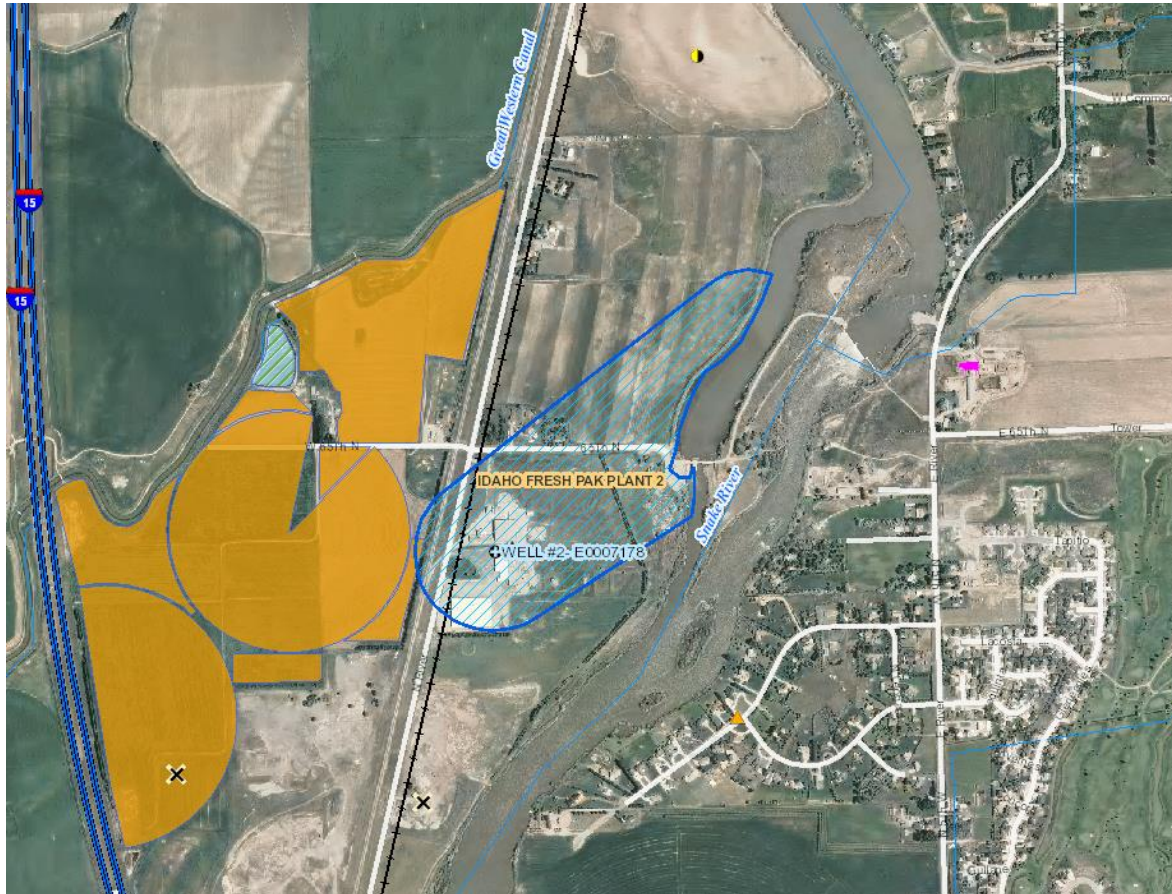
**Idahoan Foods Backup Public Water Supply Well #2 and Estimated Capture Zone.**

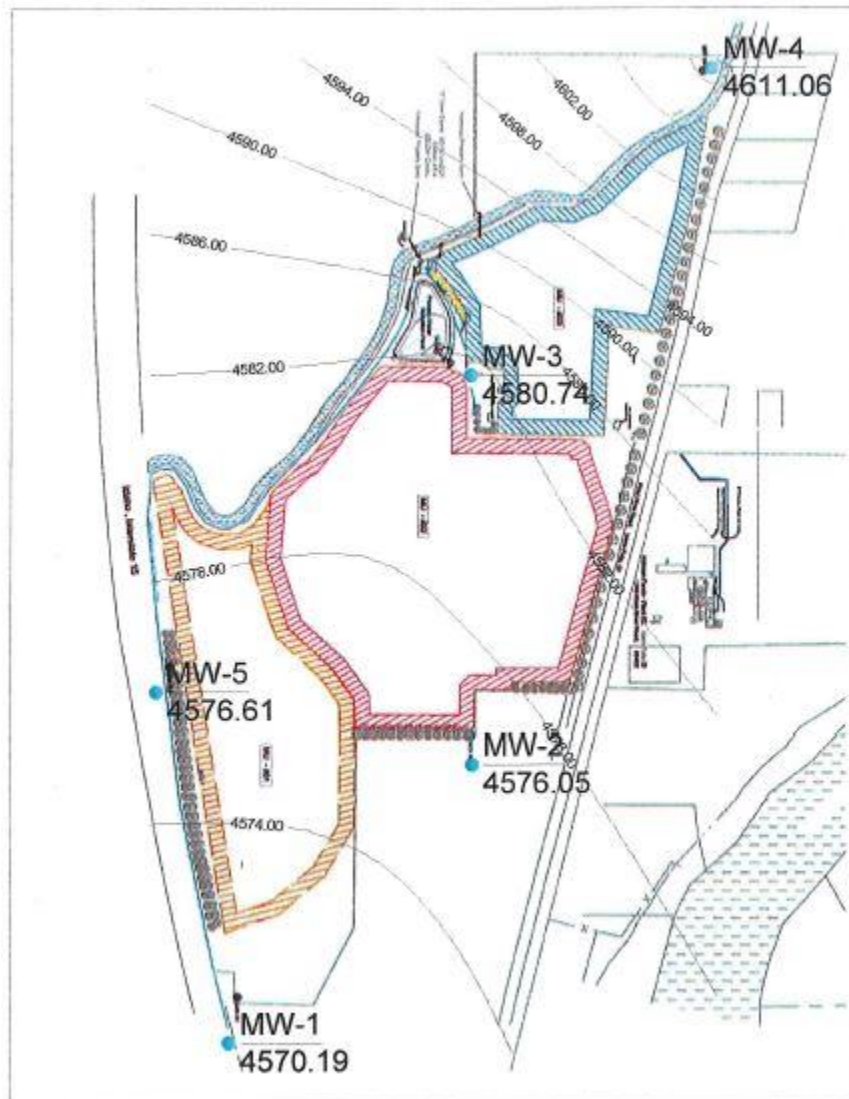
**October 2014 Ground Water Contours:**

The Idahoan Foods – Idaho Falls facility is located above the Eastern Snake River Plain Aquifer, which is approximately 165 feet deep and flows in a south-southwest direction under the reuse site. Alluvium soils overly basalt and fractured basalt. Well logs for on-site monitoring wells indicate basalt layers are first encountered between 5-15 feet below ground. Two of the monitoring wells indicate a 5-7 foot thick clay lens in the vadose zone between 110 and 130 feet deep. Annual report data shows static water levels of the aquifer range between 165 feet deep in the spring to 145 feet deep in the fall, indicating influence from regional recharge during the irrigation season. The hydraulic gradient of the aquifer is around 0.02 ft/ft on the upgradient portion of the site, reducing to approximately 0.001 ft/ft on the downgradient portion. It is estimated that ground water underneath the reuse site is replaced roughly twice per year due to the high hydraulic conductivity.
